Seeing Is Believing: The Case For Potholing

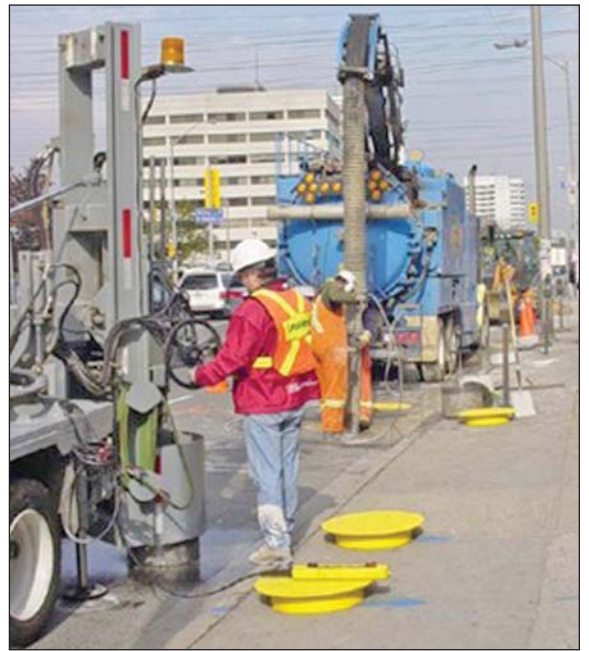
Potholing conflicts in advance of HDD with coring truck in foreground, vacuum truck in background, yellow safety road plates to cover hole between operations and several cores awaiting reinstatement.

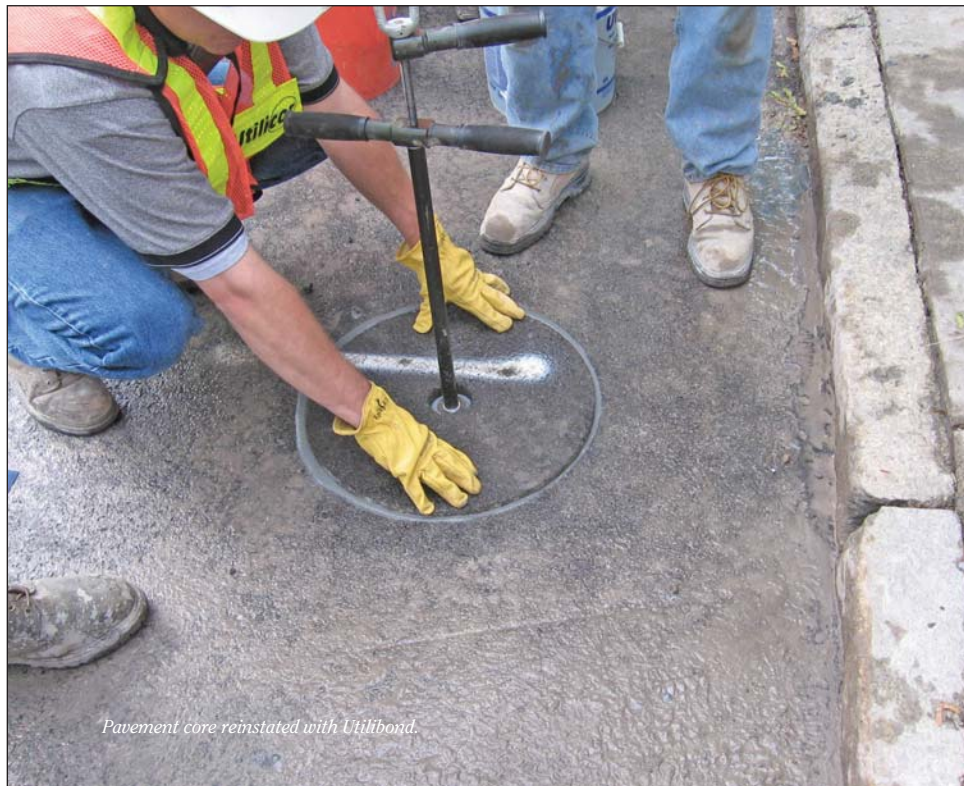
Pavement core reinstated with Utilibond.

pavement and the core or "coupon" that was originally cut from the pavement can be re-inserted back into the road surface with a special bonding compound called Utilibond that results in a permanent repair. Because the resulting mechanical bond between the core and the original pavement restores the performance capacity of the road to its pre-excavation levels, no further re-paving or site visits are required. In just 30 minutes the reinstated core can support more than 50,000 pounds – five times the H-25 AAS-HTO Standard – and the road can be safely reopened to traffic.

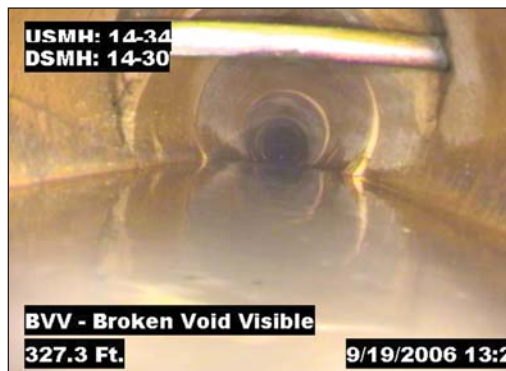
2-inch PE gas pipe cross-bored through an 8-inch sewer lateral.

Crossbores occur when crews using trenchless procedures such as horizontal directional drilling or pneumatic piercing tools cut through unmarked sewer laterals. Because this process takes place out of sight under the ground and the downhole sharp-pointed drilling tool passes easily through the walls of the sewer lateral, it often goes unnoticed by the crew on the surface. Unaware of what has happened below ground, the crew pulls the new gas or electrical conduit back through the damaged lateral where it can go unnoticed for years, leading some observers to dub it “an accident waiting to happen” or more colorfully, “a ticking time bomb.”
