## **Product Spotlight**

# **New Core Patch Bonding is Stronger than Pavement**

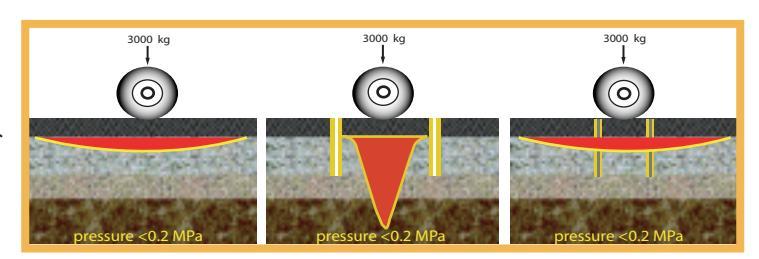
The illustration on the left shows how the normal uncut road distributes the surface load transversely through the pavement (the red area) in accordance with its design.

The center illustration shows the result of a conventional utility cut repair in which, because the edge of the repair has not properly bonded to the remaining pavement, the road has not been reinstated as a system. In this case the surface load is not transmitted laterally beyond the perimeter of the cut, with the result that the pressure (the red area) is concentrated downward in a vertical plane directly into the

Utility cuts reinstated with Utilibond restore the ability of the road to perform as a system and share the surface load laterally as originally designed, thereby minimizing damage to the sub-grade.

sub-grade where it can contribute to a more rapid deterioration of the roadway. In extreme cases, the pavement cut repaired in the conventional way, may actually "float" free of the rest of the surface resulting in surface cracking and spalling.

Finally, the illustration on the right, shows the results of a utility cut reinstated with Utilibond<sup>TM</sup>. In this case the core and the balance of the pavement have been reintegrated into a load-bearing system, capable of laterally transmitting the surface load across the original cut lines to the remainder of the roadway. The reinstated roadway is again capable of performing in accordance with the original pavement design specifications.

"Effective coupling is achieved where the road will share the effect of traffic loading, as postulated in conventional road design theories," says Sandy Brown, project manager at Golder Associates, the international engineering firm which has monitored the development and implementation of the process over the last 10 years. "Our lab trials and field demonstrations on the rotary cutting method have shown that the reinstated pavement coupon has been bonded into the slab in such a manner that the loads of traffic are effectively transmitted to the remaining intact slab and the road is as good as it was before the excavation." (see figure below)

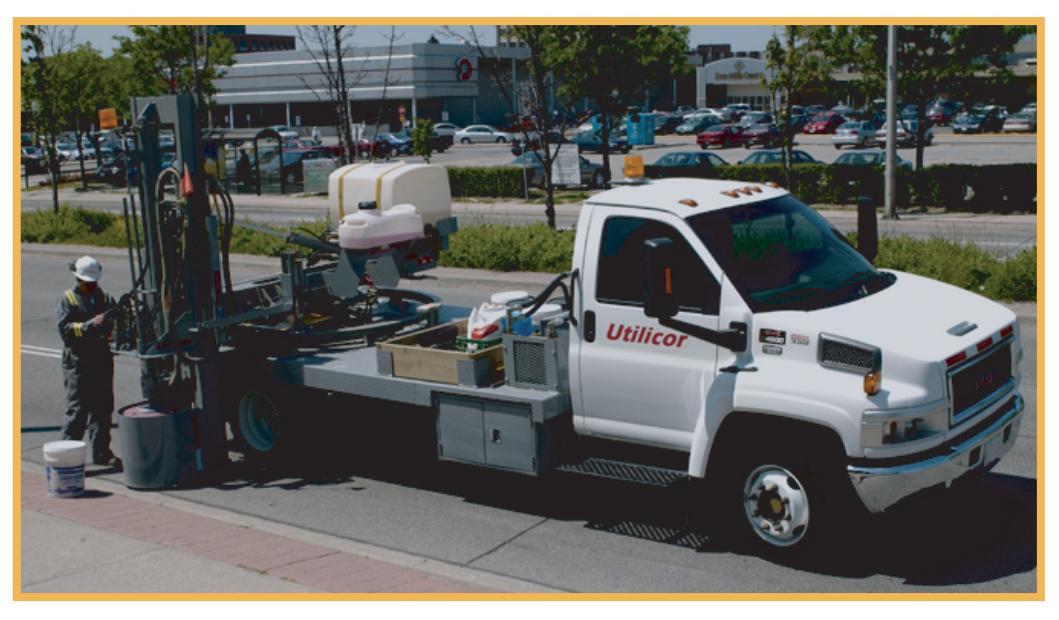
The Utilicor coring unit operates through a complete 270° arc, allowing the truck to be positioned on the shoulder or off the traveled surface to minimize traffic disruption.
