## Keyhole Coring Technology: Cost Saving Solution For Underground Main Repairs

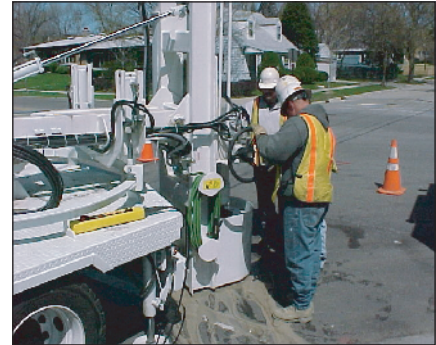
Bellwood's crew coring the roadway in preparation to repair a bell joint.

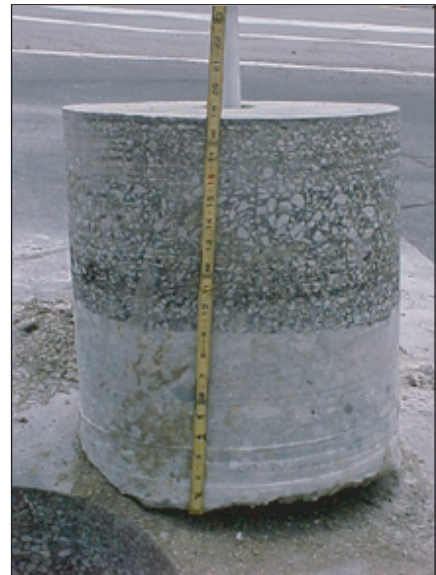
After completing the underground pipe repair, the Nicor crew reinstated the massive 19-inch composite, asphalt and concrete core using Utilibond for a permanent pavement repair

"Once the repair has been completed," Jones said, "the hole is backfilled and the core cemented back into place with a special bonding compound, Utilibond. The roadway is as good as new."
